Integra™

Wound Matrix and Bilayer Wound Matrix

TRAUMA
CASE STUDIES

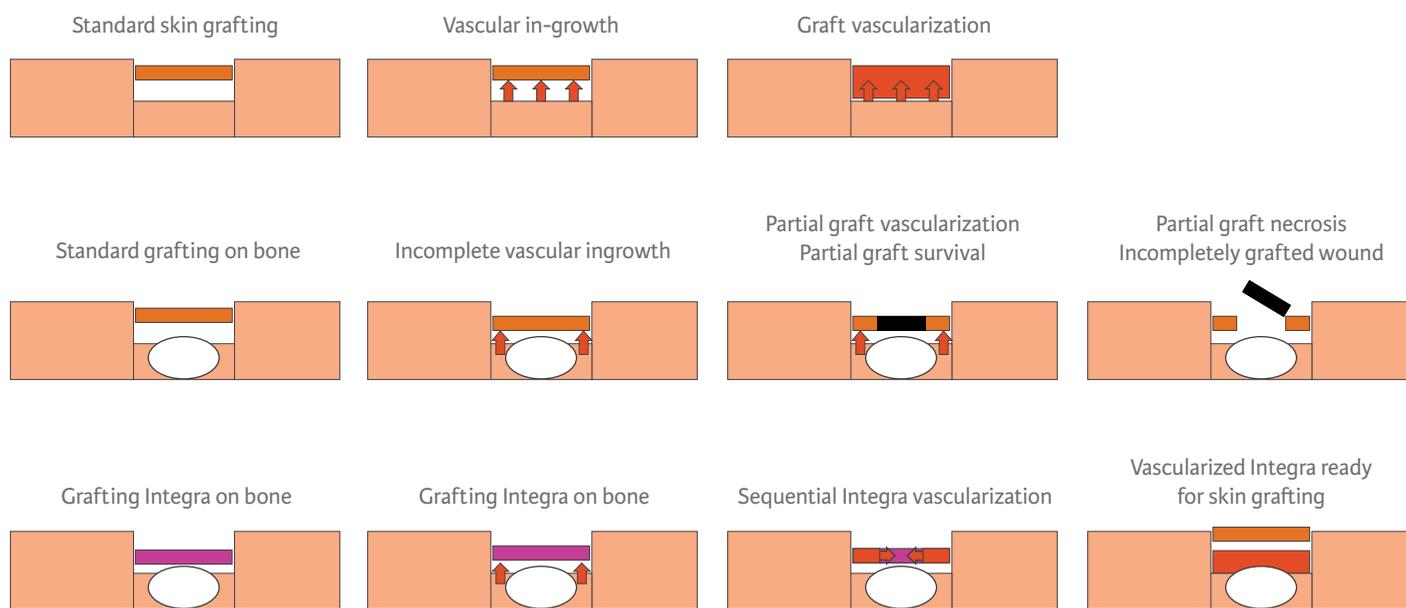
Schematic demonstrating how Integra works

(Top) Standard split-thickness grafting requires vascular ingrowth for successful vascular ingrowth and graft take.

(Center) Because cortical bone and tendon are poorly vascularized, there is incomplete vascular ingrowth into a split-thickness graft over these tissues. Graft is unable to be sustained while waiting for delayed vascular ingrowth.

(Bottom) Because Integra is not reliant on vascular ingrowth, vascularization over a period of several weeks can be accomplished and split-thickness grafting can be performed over a well-vascularized bed of neodermis.

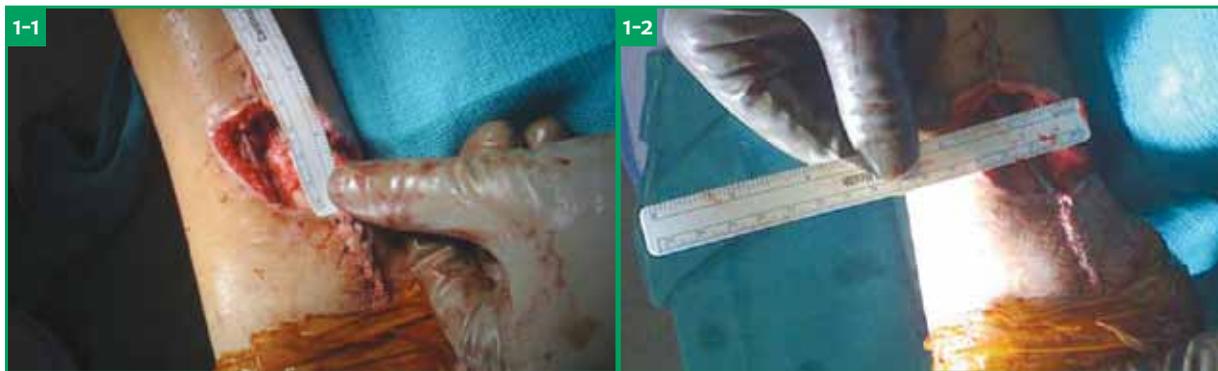
Intraoperative photo of traumatic wound at the time of Integra placement

The patient is a 14 year-old female involved in a motor vehicle accident with ejection. In addition to her traumatic brain injury, she also suffered a left open pilon fracture with the traumatic opening initially measuring 10 cm x 4 cm (Figures 1-1 and 1-2). On the night of presentation, she underwent irrigation and debridement of her wound. There was also placement of an ankle spanning external fixator device as well as Negative Pressure Wound Therapy (NPWT). Due to gross contamination of her wound, she underwent three serial debridements prior to definitive open reduction and internal fixation of her fracture on post injury day #11. Four days later she underwent Integra placement and NPWT at -75 mm Hg continuous setting for 10 days, after which she had an uneventful split thickness skin graft placement. At her final follow-up, three months later, the wounds had an excellent clinical outcome and she had returned to normal activity (Figure 1-3).

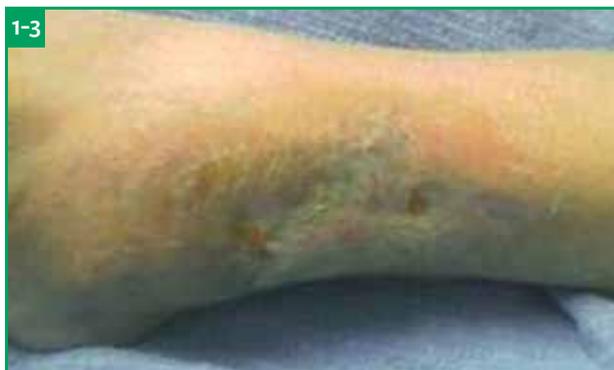
Clinical Photo three months after Integra placement

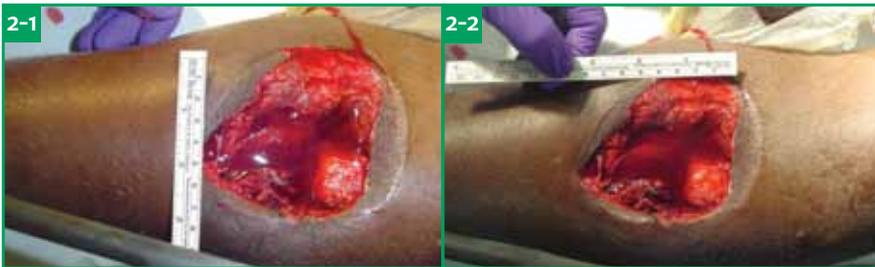
Intraoperative photographs of the traumatic wound on the date of injury

The patient is a 23 year-old African American male who was shot in his left tibia at close range with a large caliber handgun. On the date of injury, he underwent irrigation and debridement of his traumatic wound (Figures 2-1 and 2-2). He also received placement of a leg spanning external fixator device and application of Negative Pressure Wound Therapy (NPWT) for his 8 cm x 6 cm wound. Six days later he underwent open reduction and internal fixation of his fracture with bone grafting (Figure 2-3), as well as Integra placement (Figure 2-4) and NPWT (Figures 2-5 and 2-6). Ten days later he received a gastrocnemius rotational flap for coverage of his wound, as well as split thickness skin grafting and application of NPWT for 5 additional days. At final follow-up four months later he had excellent soft tissue coverage and had returned to normal activities (Figures 2-7 and 2-8).

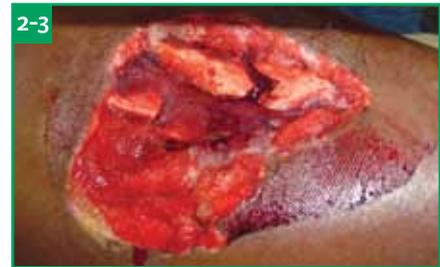
Intraoperative photograph of traumatic wound after 6 days of NPWT

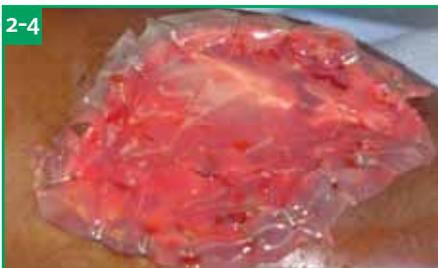
Intraoperative photograph of wound after placement of Integra

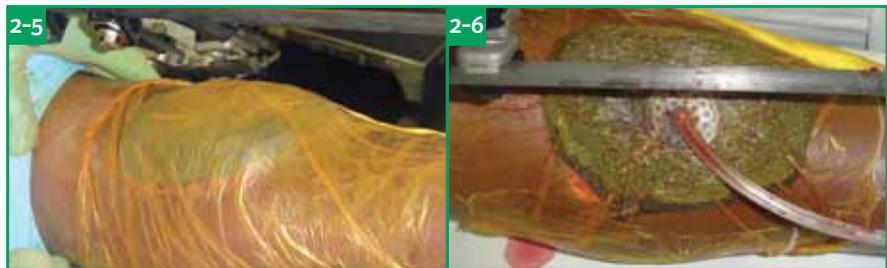
Intraoperative photograph of wound with Integra and NPWT

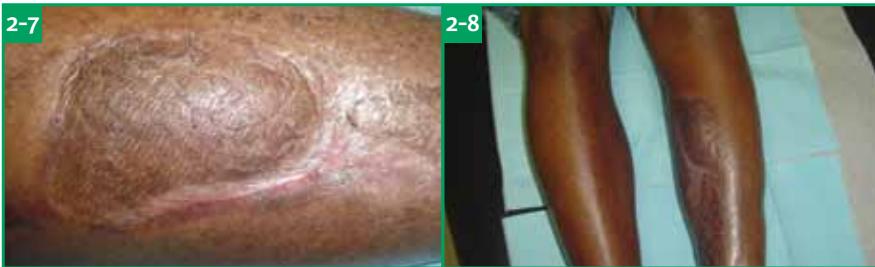
Clinical photograph of appearance of the wound four months after Integra placement, gastrocnemius rotational flap coverage, and split thickness skin grafting

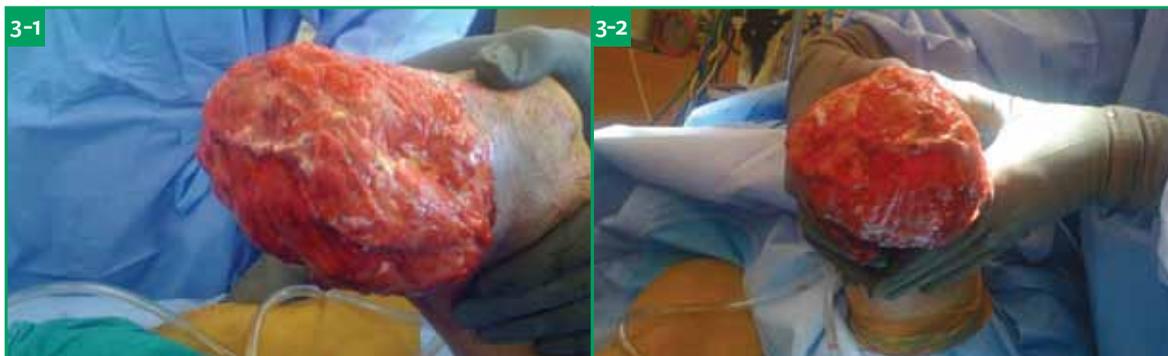
Intraoperative photograph of below knee amputation site just prior to Integra placement

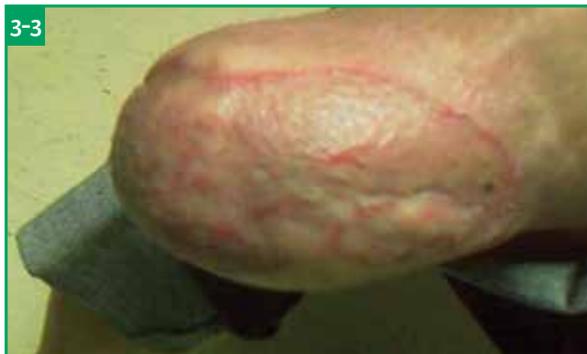
Clinical photograph of wound three months after split thickness skin grafting

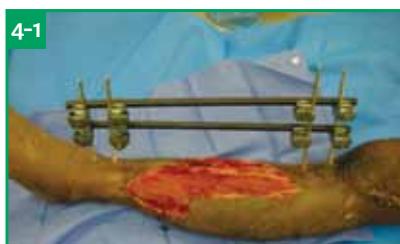
4-1
Intraoperative photo at time of free latissimus dorsi muscle flap placement (10/11/05)

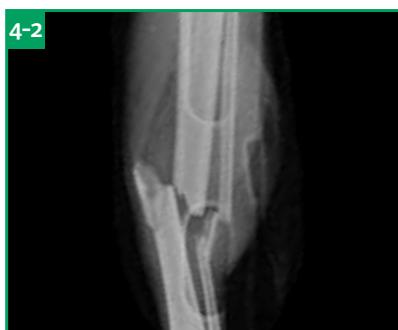
4-2
AP radiograph of the tibia and fibula on the day of presentation

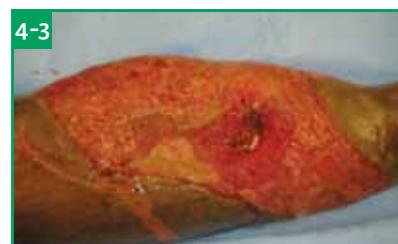
4-3
Intraoperative photos of the exposed tibia roughly two months after free muscle flap placement. The close-up image in Figure 4-4 reveals the three attempts at drilling into the bone. No bleeding was noted at any time from the bone. (12/10/05)

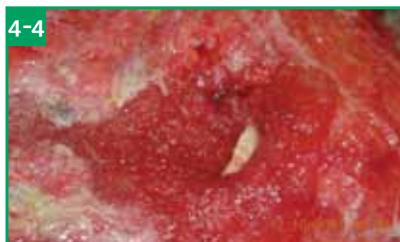
4-4
The close-up of image 4-3

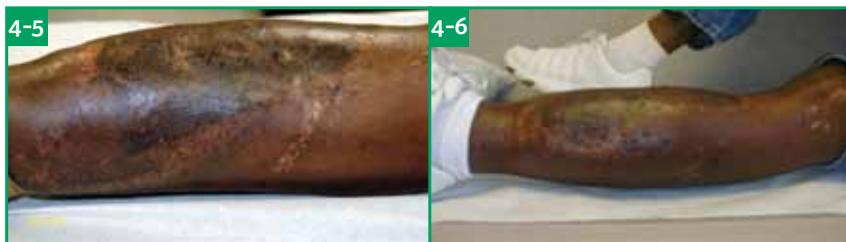
4-5
4-6
Clinical photos eight months after placement of Integra and STSG. No signs of failure, full healing noted. (8/2006)

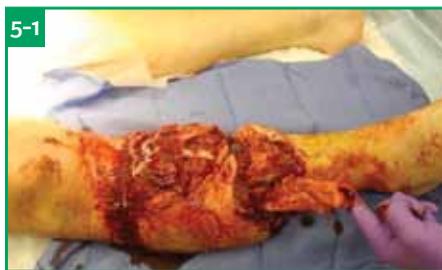
Mangled lower extremity on day of injury

The patient was involved in a motorcycle collision in September of 2008. The mangled lower extremity could not be salvaged (Figure 5-1) and a Below Knee Amputation (BKA) was performed at an outside facility. The remaining muscles were rearranged to cover the tibial stump, however there was insufficient skin to cover the muscle (Figure 5-2). The muscle bed was healthy enough to support application of a Split Thickness Skin Graft (STSG), however, a STSG alone was thought to be potentially insufficient to withstand the demand of a prosthesis over the stump. A decision was made to first cover the muscle with Integra and then seven days later apply a STSG (Figures 5-3 and 5-4).

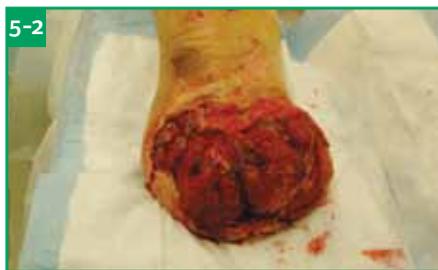
Below knee amputation site after one week of serial debridements

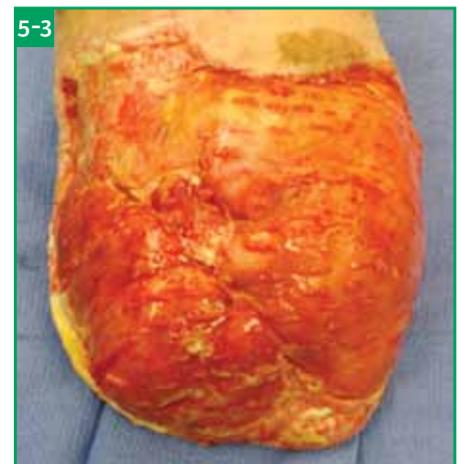
One week after application of Integra and NPWT

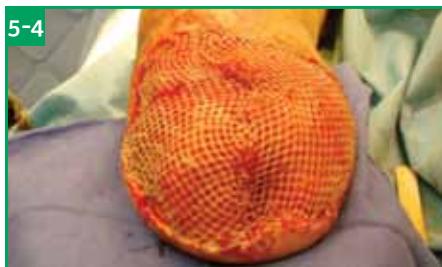
Intraoperative photo after placement of STSG over the Integra

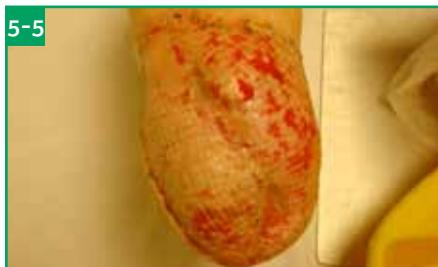
14 days after application of STSG and NPWT

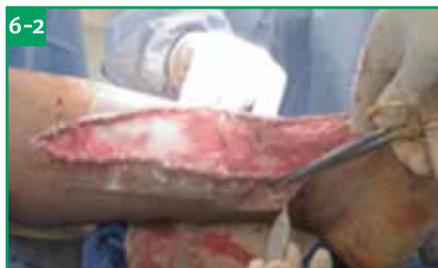
6-2 Application of Integra over the medial leg wound. The Integra is covering exposed tendons and bone

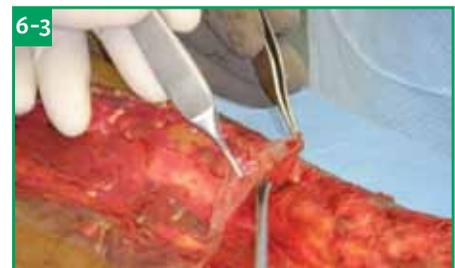
6-3 Intraoperative photo four days after Integra placement. The silicone layer is being removed and a STSG will be placed. Care is taken to not pull up the Integra collagen layer

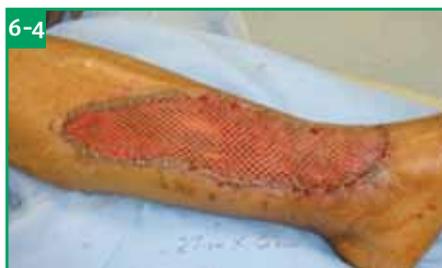
6-4 Intraoperative photo just after placement of the STSG and NPWT over the STSG

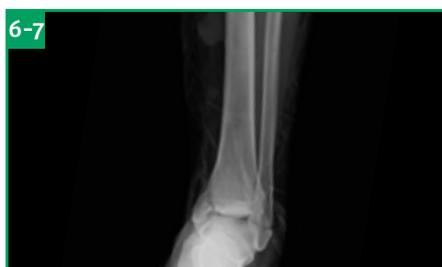
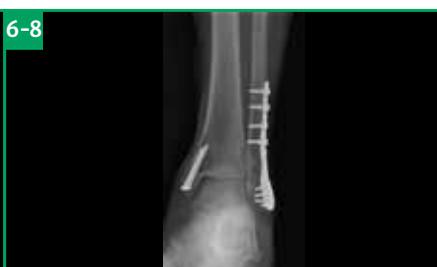
6-7 Ankle radiograph on day of injury and post-operative image seven months later

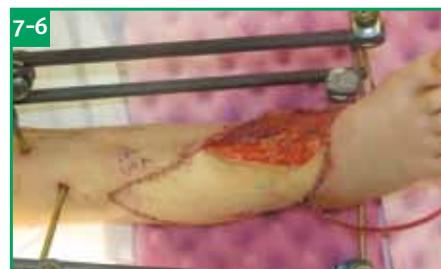
7-6 ALT free flap coverage. Medial portion of wound had tendons and hardware exposed. Integra was elected for coverage of this area. No bolster was utilized to prevent any pressure on free flap.

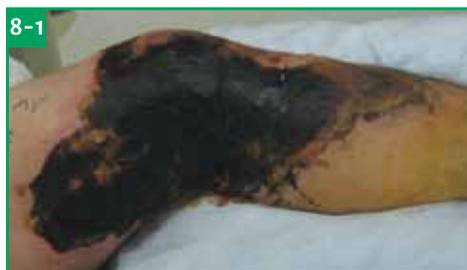
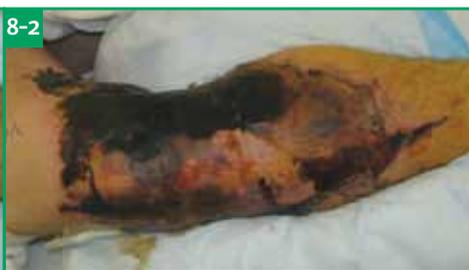
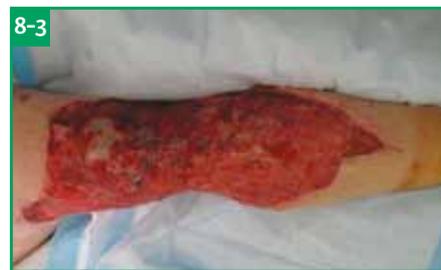
Internal degloving injury after motorcycle accident. Prior to any debridement

After staged debridement and VAC. Patellar tendon exposed. Knee joint also at risk for stiffness. Integra was chosen for coverage.

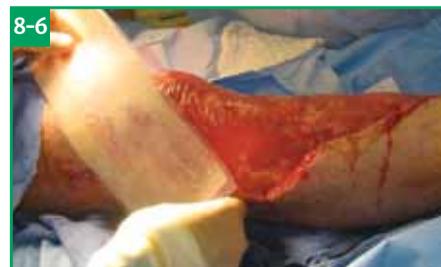
Placement of Integra

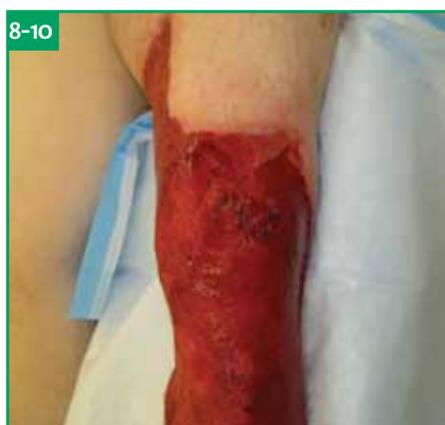
8-10
VAC left on after removal of silicone.
MUA by ortho also resulted in additional
tear to patellar tendon secondary to stiffness

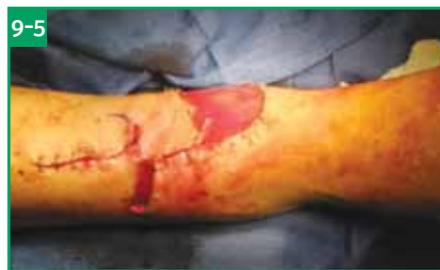
Local rotational flap coverage with Integra buried and also utilized for donor site

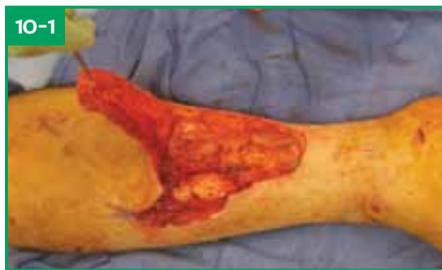
Resolved wound and the fasciocutaneous rotational flap which has been elevated. The fracture line is visible and is exposed prior to coverage

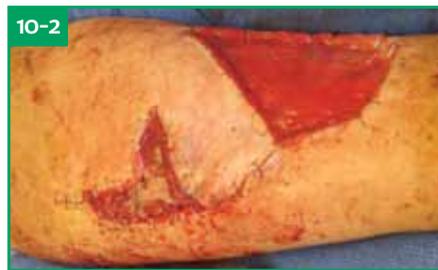
Flap elevated and rotated. Integra has been buried underneath the flap. The bilaminar matrix was placed on the donor site
